STAFF REPORT

SUBJECT: New Recreation Centre Next Steps

MUNICIPALITY OF THE DISTRICT OF BARRINGTON INFRASTRUCTURE ASSESSMENT AND RECOMMENDATIONS

MUNICIPALITY OF THE DISTRICT OF BARRINGTON RECREATION CENTRE ASSESSMENT

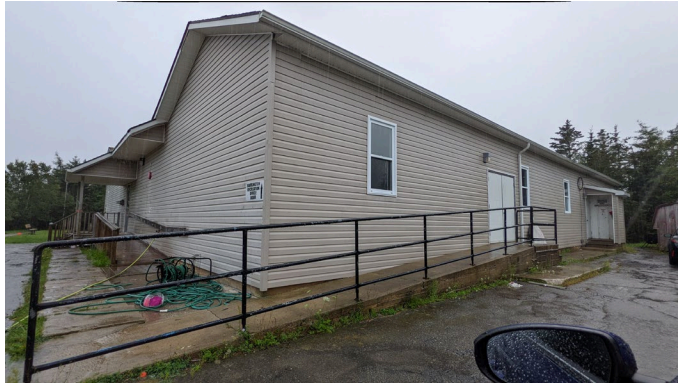
Photo 1: Northeast Corner of the Building

The existing access ramp does not meet current codes for accessibility. Safety concerns include the horizontal guardrail bars opening dimensions between structural components, lack of required flat areas at top and bottom, clearance at exterior door swings, and lack of handrail extension.

Additional maintenance and potential concerns for water ingress include the lack of a rain gutter on the side shed roof, and the single rainwater leader at centre of elevation adjacent double door.

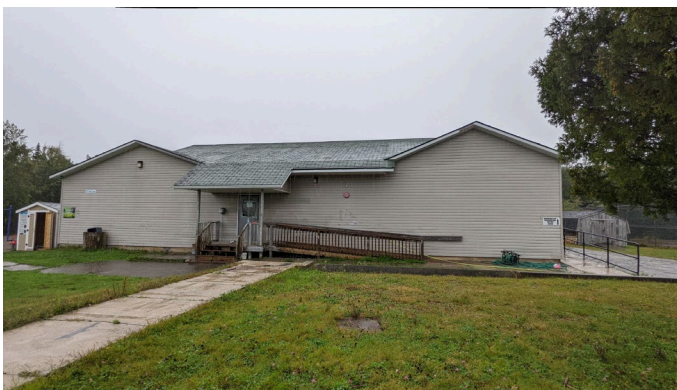
Photo 2: East Elevation (Front Entrance)

Missing rain gutter and rainwater leaders at main entrance roof above access stair and rap result in safety concerns for slippery surfaces. Lack of water control also contributes to building envelope damage and potential water ingress.

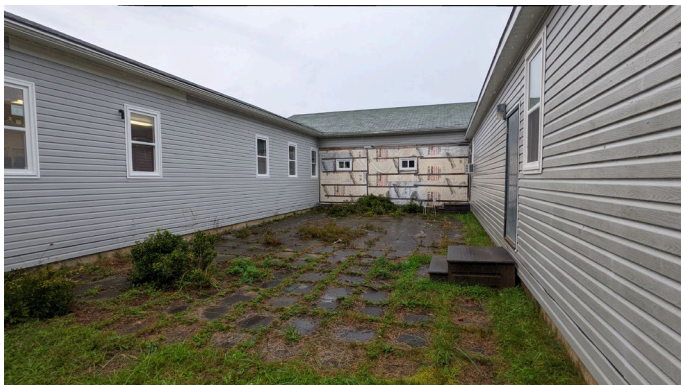
Photo 3: West Elevation (Courtyard) – Wall Damage

Photo shows the two re-purposed DND structures with connection area which create an exterior courtyard. Note the new window mounted air conditioner on right side. The connection area wall was observed to be “Soggy” with exposed, weathered air barrier. This does not provide a weather resistant cladding, allowing water infiltration to the interior. See also Photo 7 below.

Note that the exposed wall covers the washrooms and the mechanical/electrical room. Both of these areas are potentially wet based on their intended use.

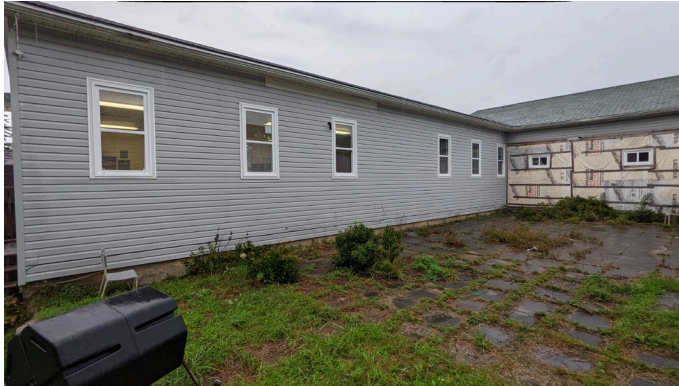
Photo 4: West Elevation (Courtyard) – Roof Damage

Roof shingles at ridgeline are missing/broken, potentially allowing water into the truss space below. This may also be contributing to the “Soggy” exterior wall below.

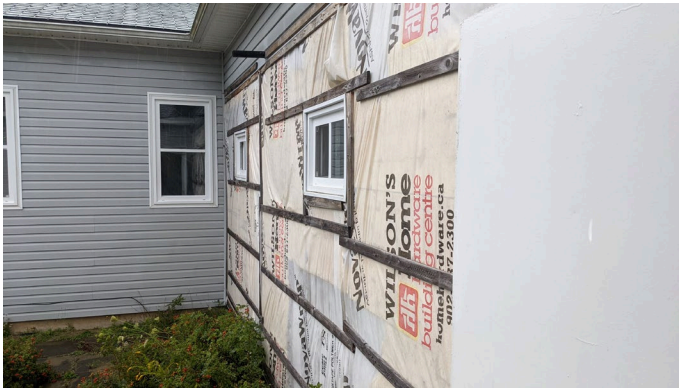
Photo 5: West Elevation (Courtyard) – Wall Damage

Weeds and bushes have grown since site visit in 2017. Lack of exterior maintenance may contribute to interior space water damage.

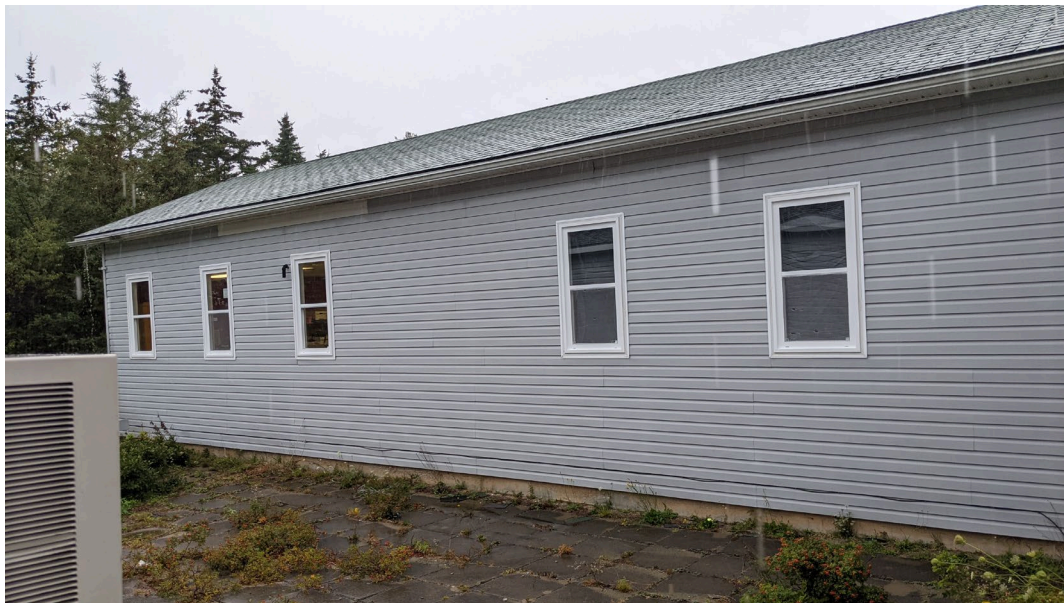
Photo 6: North Elevation (Courtyard)

This area presently houses the daycare facility. Note: roof condition deterioration compared to original 2017 assessment.

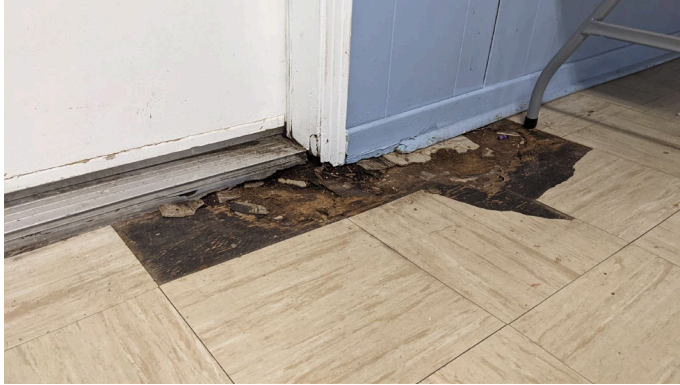
Photo 7: Courtyard Door Water Infiltration

On-going water infiltration at exit door has caused floor rot below broken vinyl floor tiles. Deteriorated floor structure is a safety concern. Additionally, broken floor tiles create a trip hazard at the exit door. See also Photo 3.

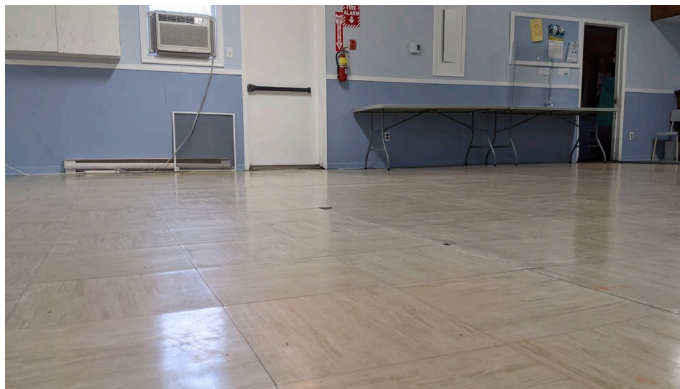
Photo 8: Uneven Floor Indicating Floor Joist Damage

Floor structure adjacent the exit door is not flat. Water infiltration from door area (above photo) may be contributing to additional damage. The uneven floor also is a safety & tripping hazard.

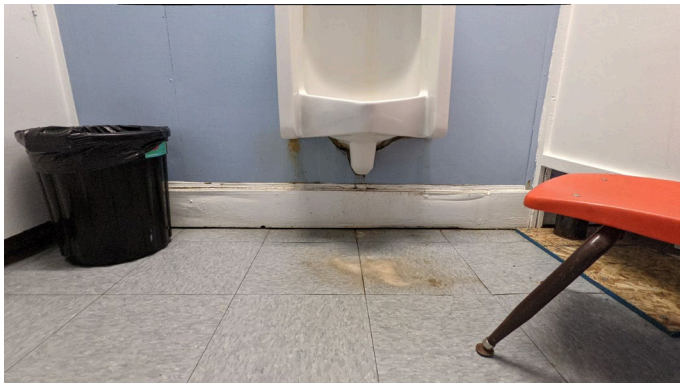
Photo 9: Male Washroom Floor Damage

Photo shows the partition wall between male and female washrooms.

Floor was damaged and recently patched at the adjacent toilet stall.

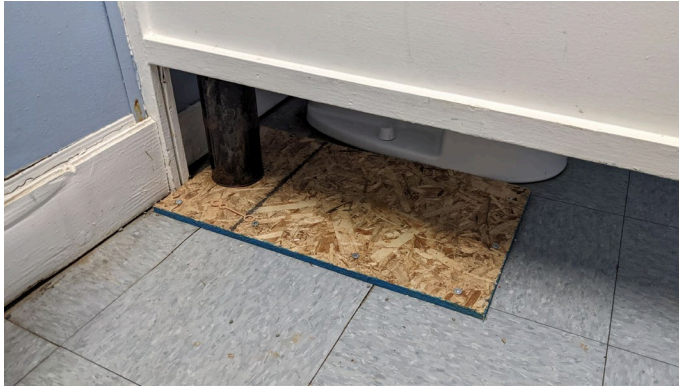
Photo 10: Male Washroom Patch

Patched area where reportedly a person put foot through floor. This is a safety concern likely the result of floor rot and deterioration caused by on-going water damage.

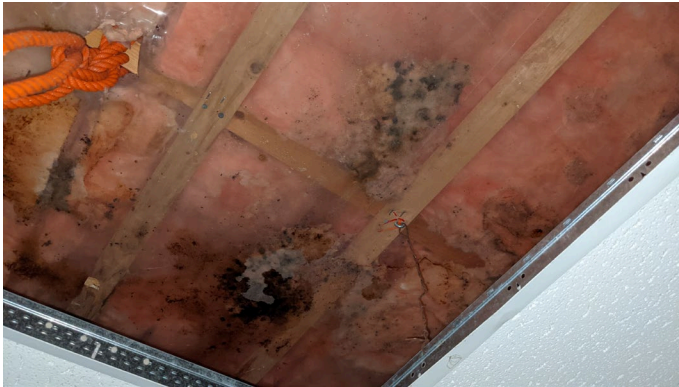
Photo 11: Roof Damage in Attic Space

Ceiling space above the music instruments storage area. Black spots may indicate mold growth. (Not tested)

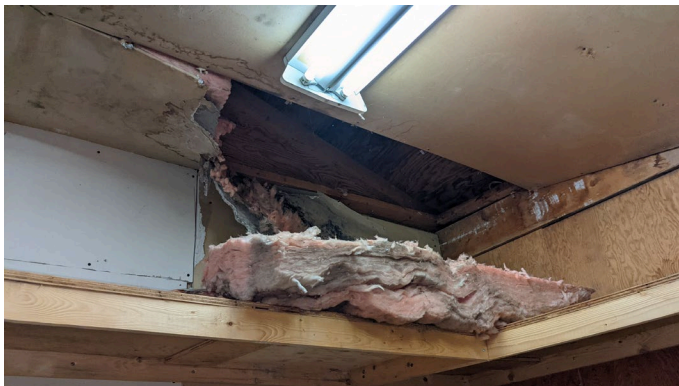
Photo 12: Water Damage & Insulation

Gypsum Board ceiling showing water damage and deteriorated insulation. No vapour barrier observed.

Water damage may be result of roof leaks or condensation.

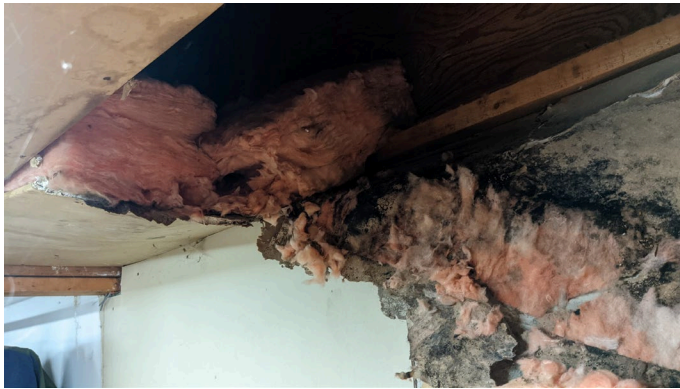
Photo 13: Water Damage and Insulation from Above Ceiling.

Deteriorated roof insulation which has come through water damaged gypsum board ceilings.

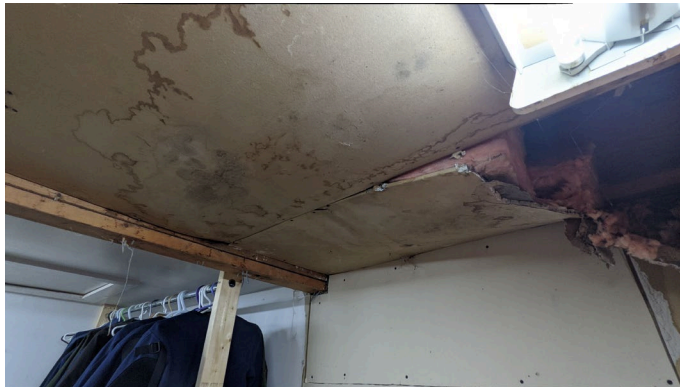
Photo 14: Water & Ceiling Damage

Ceiling of Cadet's storage area near front of building beside shed showing water damage from truss space above.

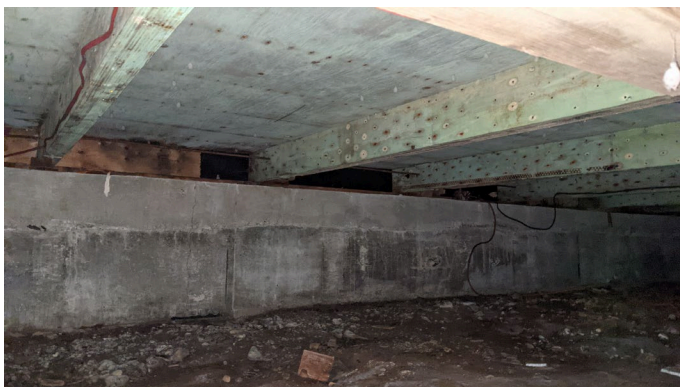
Photo 15: Crawl Space Under Building

Concrete support beams with timber joists appear to be dry and in good condition.

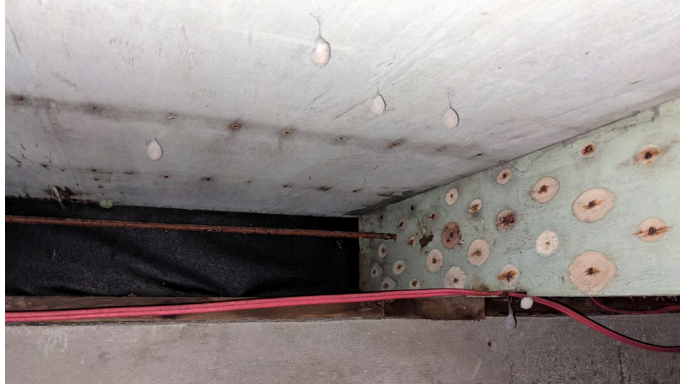
Photo 16: Crawl Space under Building

Timber floor joists supporting the Recreation Centre floor above. Rust on nails for joists is not a concern.

Area is generally dry, supporting concern that water damage is coming from above.
